Site Address: HAGGARD PARK  
Date: 11-2-01

Haggard Park

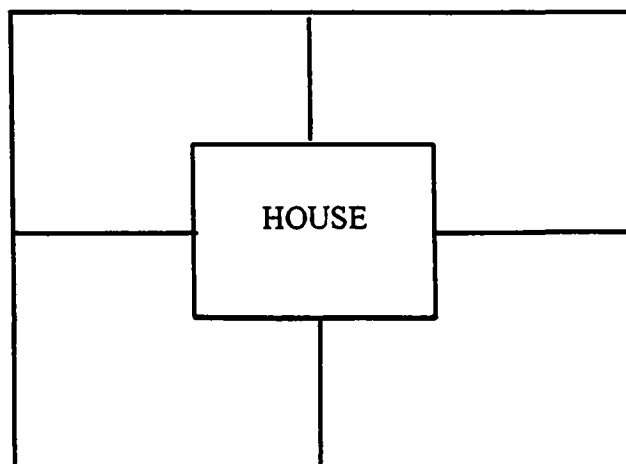
Site Sketch:

Quad 4  
Length: \_\_\_\_\_  
Width: \_\_\_\_\_

Quad 1  
Length: \_\_\_\_\_  
Width: \_\_\_\_\_

Quad 3  
Length: \_\_\_\_\_  
Width: \_\_\_\_\_

Quad 2  
Length: \_\_\_\_\_  
Width: \_\_\_\_\_
